# The Impact of Nepal's 2015 Gorkha Earthquake-Induced Geohazards

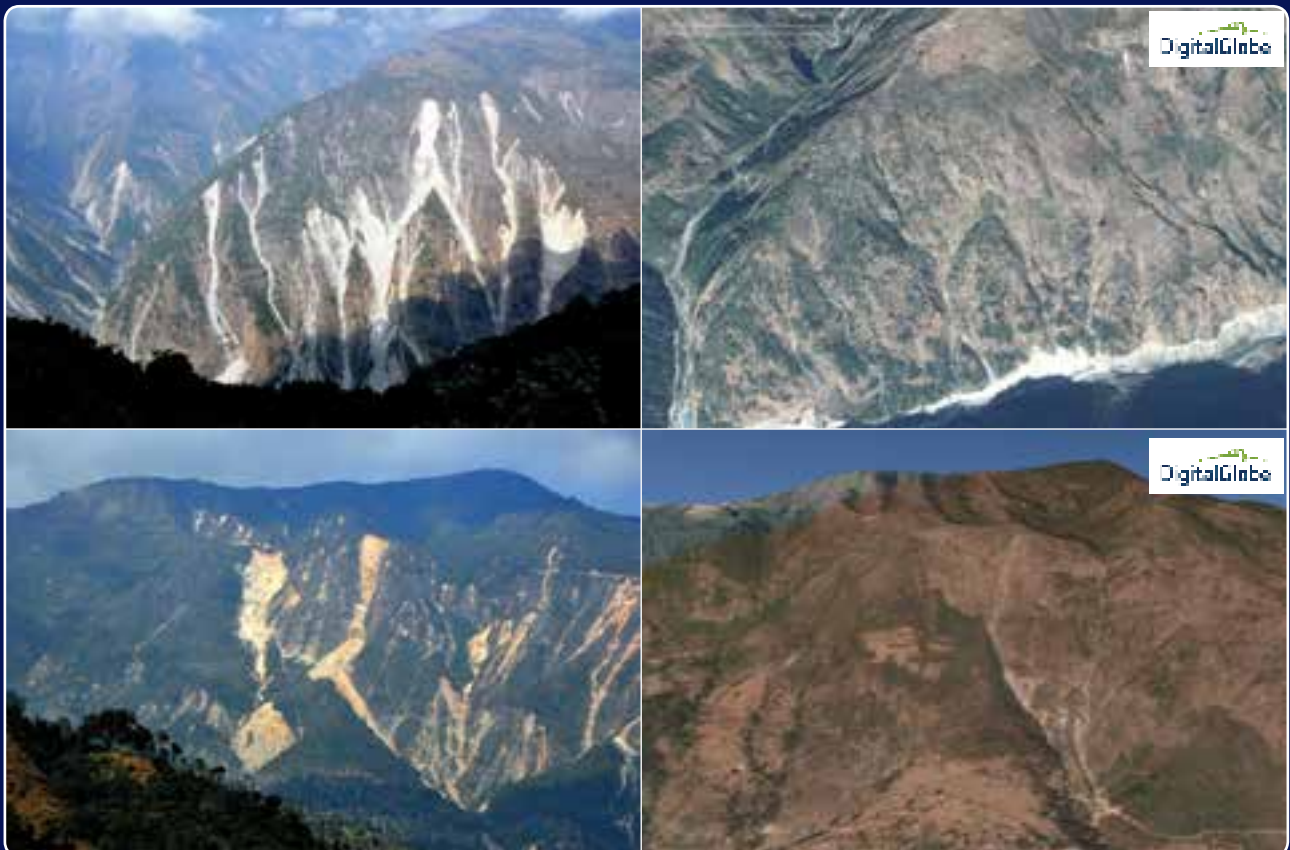
Figure 5: Examples of landslides in Rasuwa (top) and Sindhupalchok (bottom) districts: to the left, field photos taken after the earthquake in July 2015; to the right, satellite images taken prior to the earthquake (top right 12 December 2014 and bottom right 27 August 2014)

Numerous landslides were identified that were either new or the reactivation of older landslides. The earthquake-induced landslides were mostly shallow (less than 5 m) failures, such as plane rockslides to wedge slides and rock falls, and debris falls and debris slides; deep seated failures were uncommon. Debris slides were the most frequent type, while rock falls were commonly triggered on steep slopes with numerous failures ranging from individual, small boulders to large falls (for example the rock fall at Tatopani village on the Nepal-Tibet border). Debris flows, valley fill collapse, and cut-and-fill failure types were also observed. The landslides mainly occurred on steep slopes, in areas of high shaking, near ridge crests, in the tectonically dropped blocks, in certain lithologies, and near lithological contacts or interbedding. The observations indicate that wave interactions with complex topography caused a general enhancement of shaking on or near ridge crests but had less impact on valley bottoms. The number and density of landslides appeared to be very sensitive to the amount of shaking; a slightly greater seismic disturbance might well generate a disproportionately larger number of landslides. Despite many concerns regarding the occurrence of earthquake-triggered landslide dams, only a few were identified.

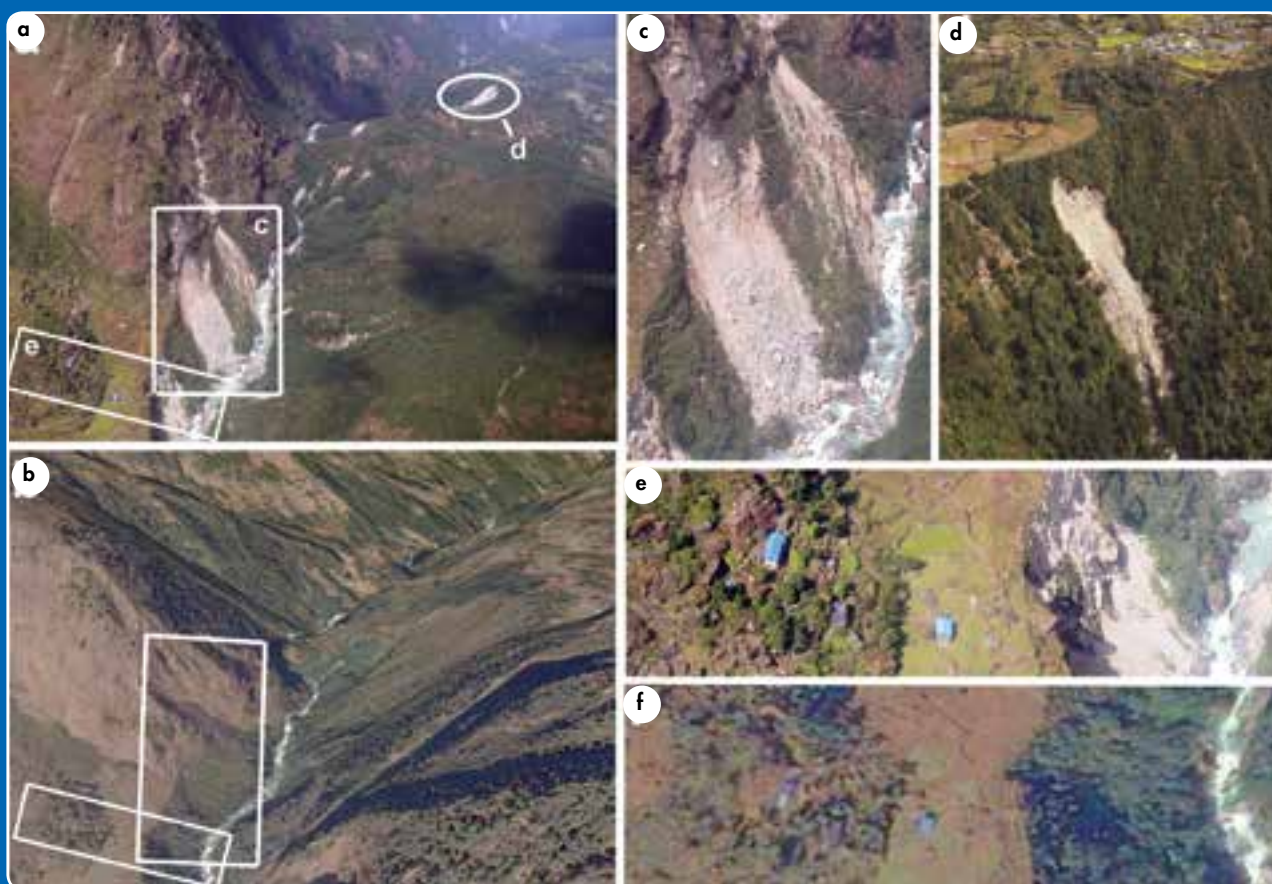
a) Oblique helicopter-borne photo acquired 27 Oct 2015. The scene width through the scene centre is about 700 m. The longest landslide is around 350 m long. b) The landslides did not exist twenty weeks prior to the earthquake, as seen in a Google Earth (CNES/Astrium) rendering of similar perspective from 6 Dec 2014. c) The three landslides that reached river level were all earthquake-related; one originated from terrace deposits, and the other two from the nose of a bedrock ridge crest composed of paragneiss. Another landslide can be seen in the distance (upper right). Peak ground acceleration (modelled) in this area was about 0.08 g, corresponding to weak shaking. (c) Enlargements from (a) showing the thin-skinned nature of these landslides. (d) A different helicopter-borne image shows an earthquake-induced landslide at the edge of Lukla (on the river's east bank) also visible in (a); this landslide also sources from terrace deposits – ancient deposits of a massive landslide which apparently blocked the river for a long time (Götz et al. 2015). (e) Enlargement of (a) shows the head scarp of one landslide, which receded by no more than a couple of metres relative to the pre-quake scene as shown in (f). This image pair also shows that the terrace source of the landslide is a boulder filled rock fall similar to that documented by Götz et al. on the other side of Dudh Koshi. Other notable features in this area are deep, weathered bedrock fractures (arrows in panels a and b), which existed before the earthquake and fortunately were not discernibly reactivated. Such fractures indicate that a potential existed for much larger landslides than actually occurred.

A landslide complex was observed 3.5 km northwest of Bhadaure (Figure 7). The calculated PGA at this point was about 0.45 g (fairly strong shaking). A helicopter overflight on 28 October 2015 confirmed the fresh nature of much of the complex, but comparison of post-earthquake DigitalGlobe imagery with a pre-earthquake CNES/Astrium image (both rendered in Google Earth) showed that a large part of the complex had existed before the earthquake, but seismic reactivation had occurred. This example highlights the need for caution when interpreting what appear to be fresh landslides either in satellite imagery or airborne or ground-based imagery. The landslide complex included landslide elements that may have been caused by earthquake-driven ridgetop shattering (Collins and Jibson 2015), with prior conditioning by earlier landslides or simply weathering or other weaknesses in the rocks.

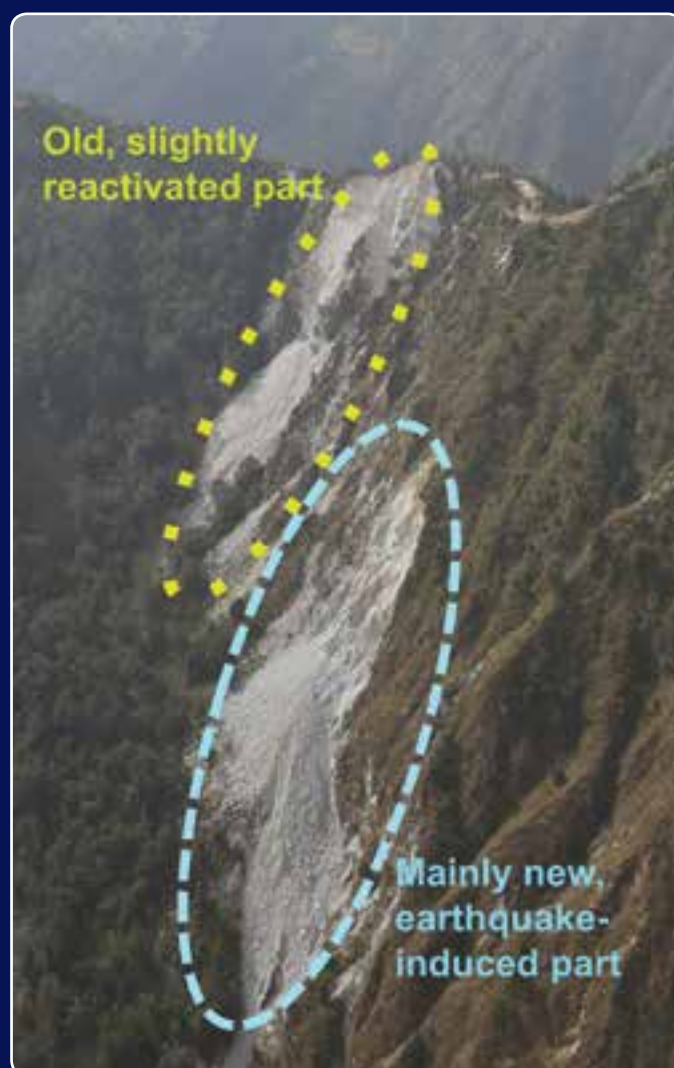
This type of ridge top failure landslide was common following the Gorkha earthquake. The landslide cluster was visible on 12 December 2014 but was apparently reactivated by the seismic event. Note that the fresh landslide does not reach the valley at the bottom of the slope.

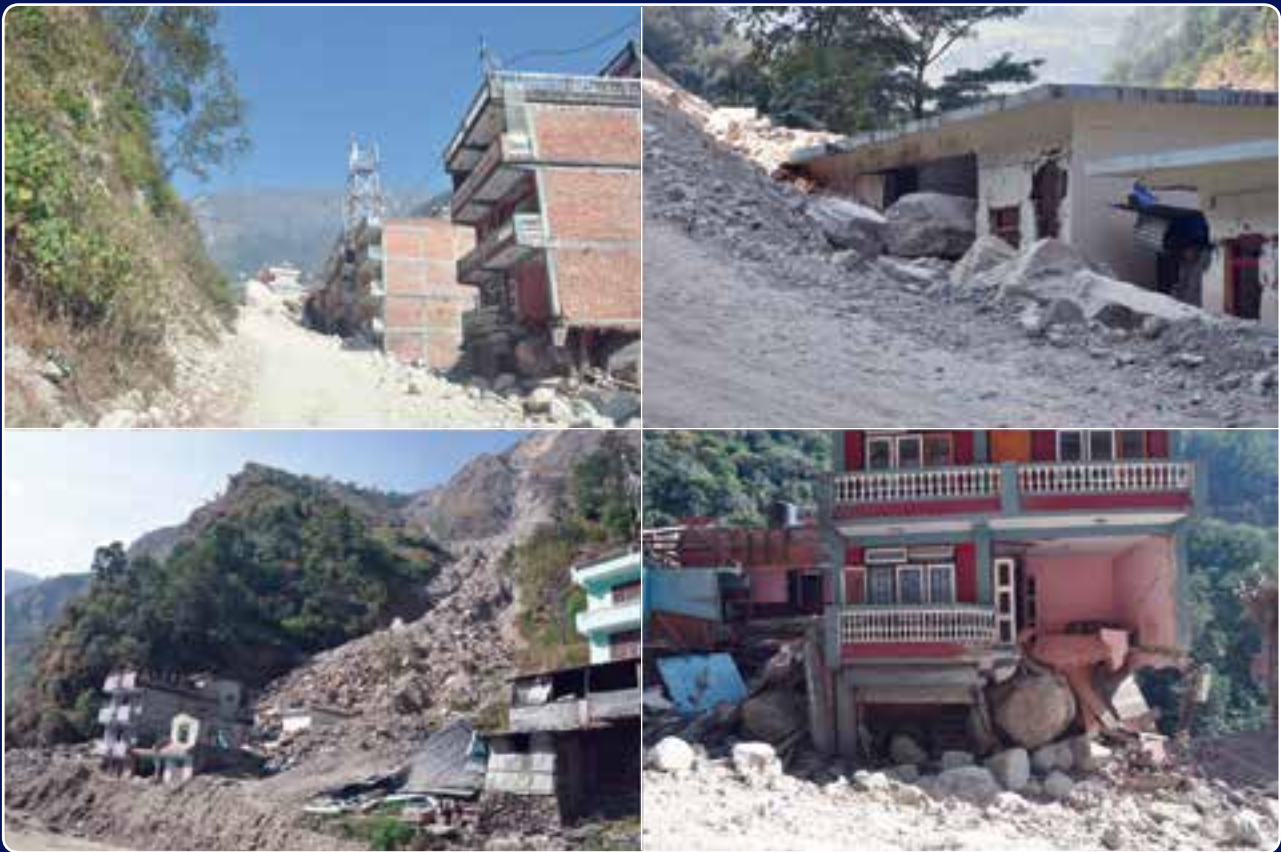
Figure 11: New settlements along the Kodari Highway were severely damaged by earthquake-induced landslides

Field visits showed major destruction of newly-developed settlements by landslides along the Pasang Lamu Highway in the Trishuli valley (Rasuwa) and Kodari Highway along the Bhotekoshi/Sunkoshi valley (Sindhupalchok) (Figure 11), whereas older settlements were less affected by geohazards. Settlements in Tatopani village (at the Nepal-China border) were also hit by rock fall from the nearby mountain.

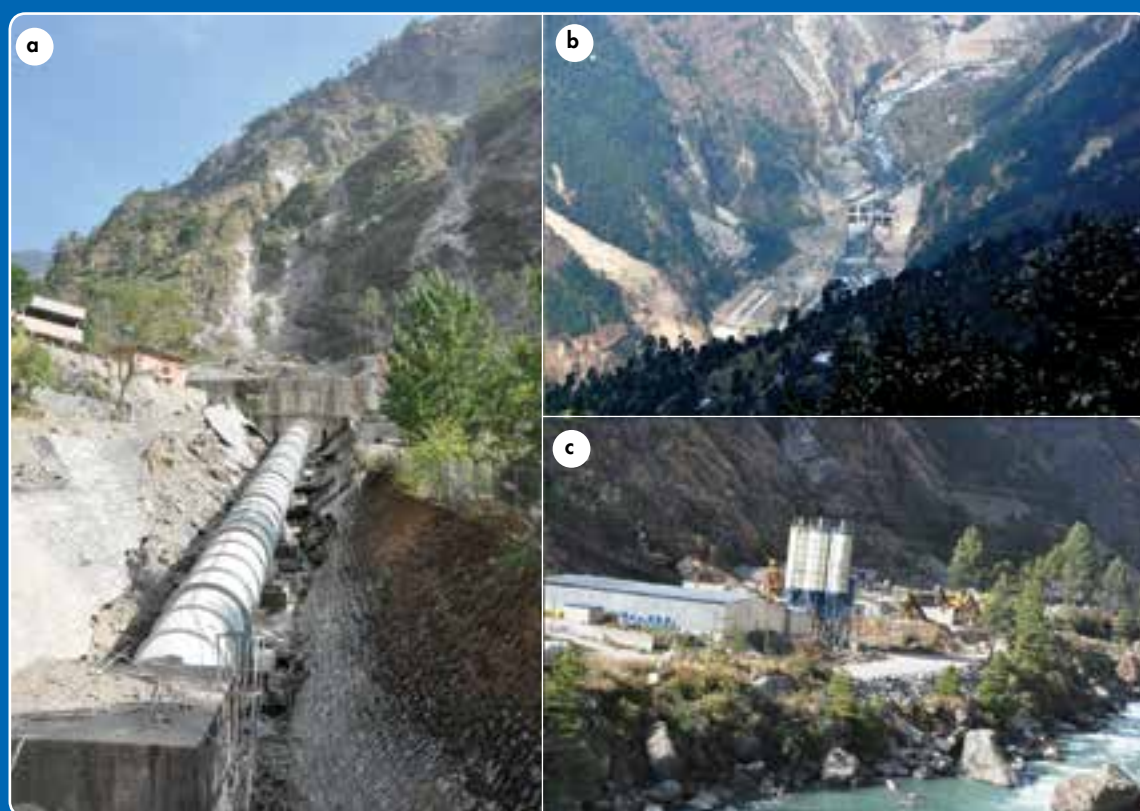
Figure 14: Hydropower plants damaged by landslides

a) Penstock of the Bhotekoshi; b) Upper Trishuli (under construction); and c) Rashuwagadi (under construction)

Figure 14 shows some of the damage suffered by existing projects and projects under construction.

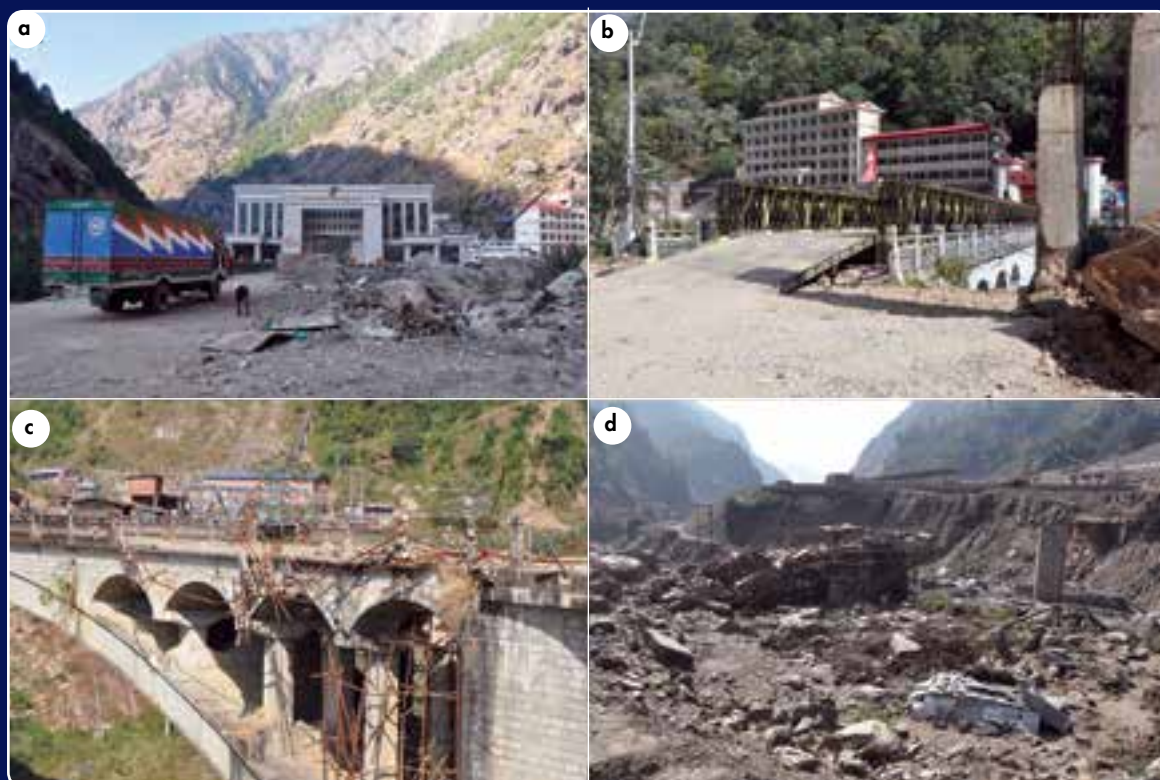
Figure 15: Bridges damaged by rock fall following earthquake-induced landslides

a) Rasuwa Gadi bridge damaged by rock fall; b) Friendship Bridge damaged by rock fall, showing Bailey bridge built by the Chinese Government for vehicles to cross; c) Phulping Bridge on the Kodari highway damaged by rock fall; d) severe damage from a rock fall to the bridge under construction to access the new dry port along the Kodari highway

Most of the bridges along the national highways survived the earthquake itself, but a few bridges were damaged or destroyed by rock falls derived from earthquake-induced landslides in the surrounding catchments. These included the bridge at Tamakoshi in Gongar, the Friendship Bridge at the Nepal-China border (Tatopani), Phulping bridge near Lharcha, and Rasuwa Gadi bridge at the Rasuwa Gadi border (Figure 15). Other bridges along minor access roads may also have been affected but as yet there is no documentation available.

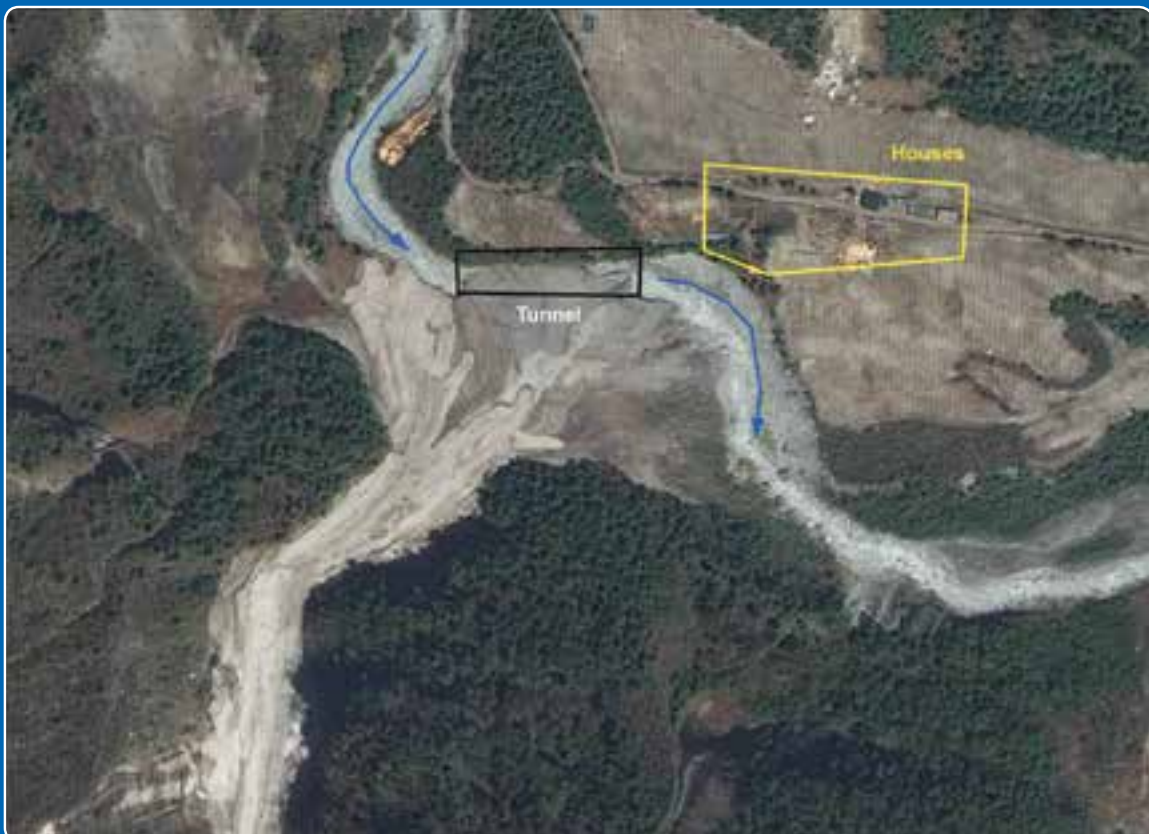
Figure 18: Landslide blocking the Marsyangdi River close to Bhratang village in Manang

risk of being washed away. The WorldView 1 image of 29 April showed the river discharging through a natural tunnel under the landslide debris, saving the houses. It is likely that this mass movement was primarily a snow avalanche.

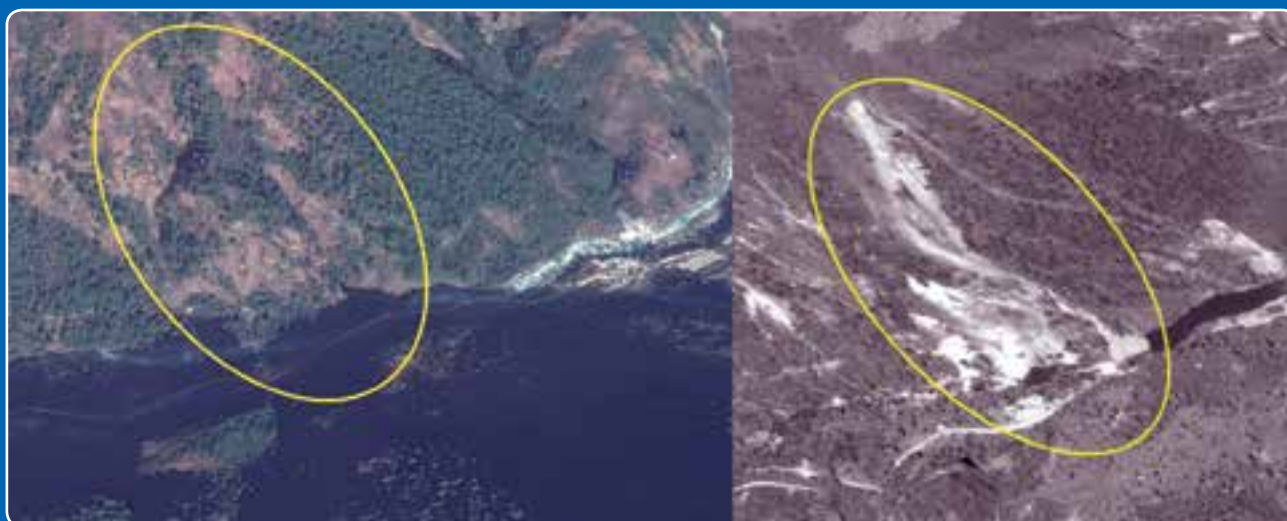
Figure 22: **Shallow landslide temporarily blocking the Sun Koshi River about 1 km downstream from Chaku village**

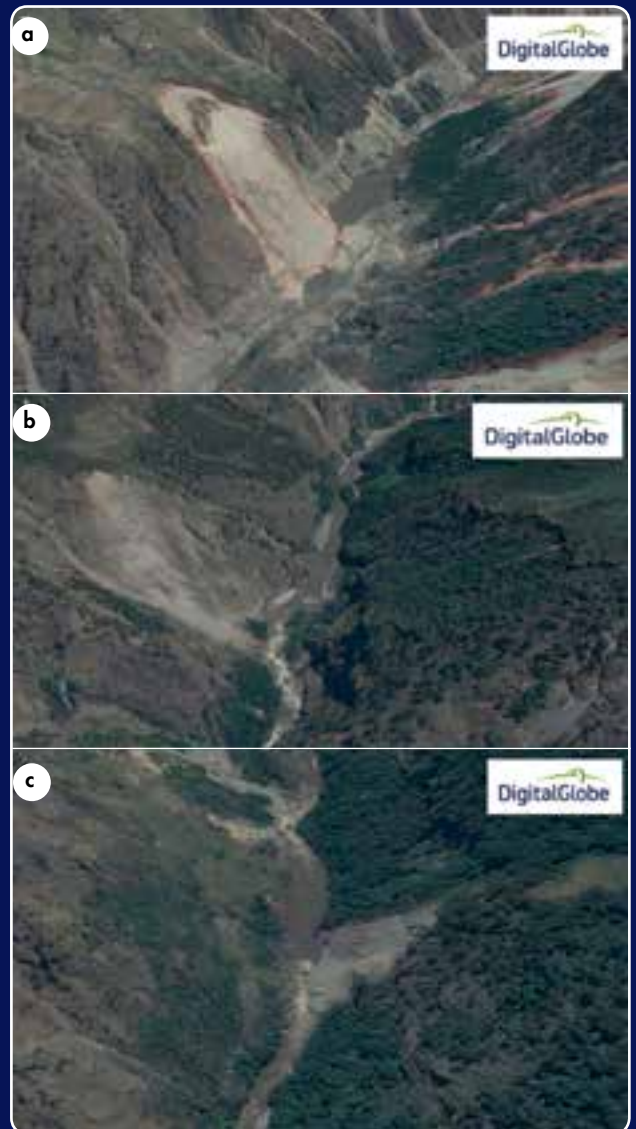
Figure 24: Landslide dams along the Trishuli River in Haku VDC, Rasuwa

Three more landslide dams, 5.5 and 4 km apart, formed downstream along the same river in Haku VDC, Rasuwa, along the route to Langtang village. None of the dams had a major impact as the impoundment was released naturally (Figure 24).

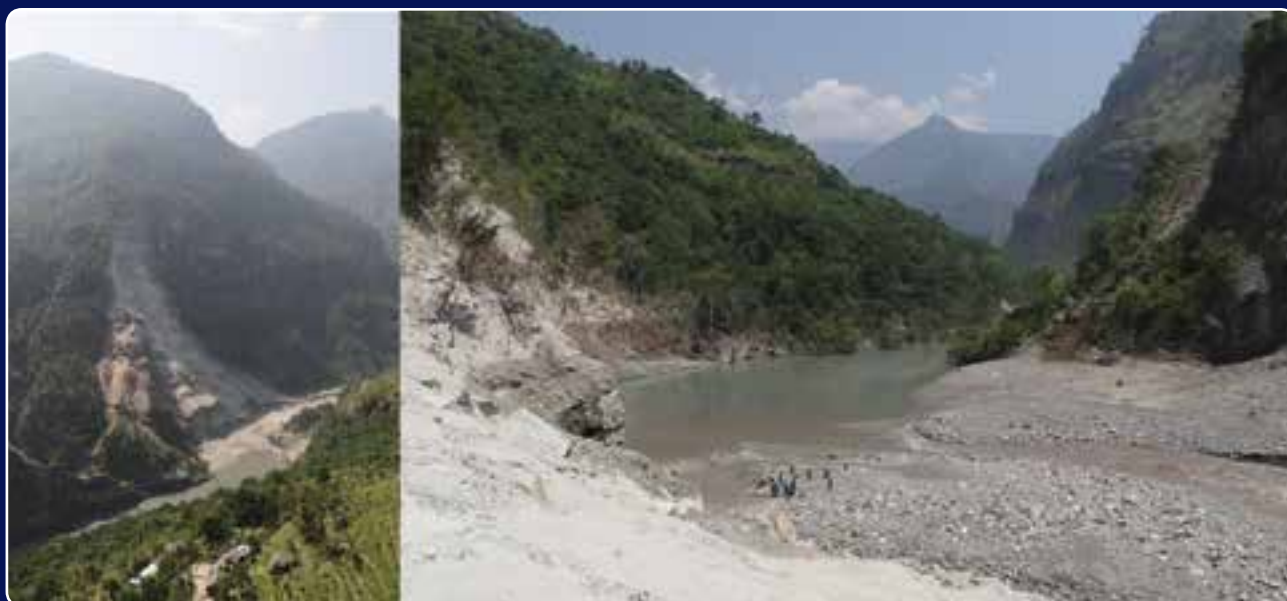
Figure 25: The rock slide along the Kali Gandaki River from 24 May 2015 that buried the village of Baisari and blocked the flow of the river for 16 hours showing the lake impoundment on 29 May 2015 after breaching

On 24 May 2015, a rock slide of approximately 350 x 200 x 4 m<sup>3</sup> buried Baisari village in Myagdi (28.400° N, 83.583° E) under about 30 m of debris and blocked the Kali Gandaki River (Figure 25). Cracks formed in the cliff following the 25 April earthquake and widened during the strong tremor of May 12. Rocks began falling from the cliff ten days later on 22 May. The Nepal Army evacuated Baisari village and the cliff failed two days later at about 1:00 am on 24 May. The landslide destroyed 27 homes and buried the entire village under the debris. A 2.7 km long and 100 m wide lake formed impounding ~8,000,000 m<sup>3</sup> of water (Collins and Jibson 2015). The lake overtopped the dam 16 hours after it formed and sent a flood-wave down the Kali Gandaki River; water levels reportedly rose temporarily to 2 m above the normal monsoon level. Fortunately, the communities downstream of the landslide dam had been evacuated, and no loss of life occurred.

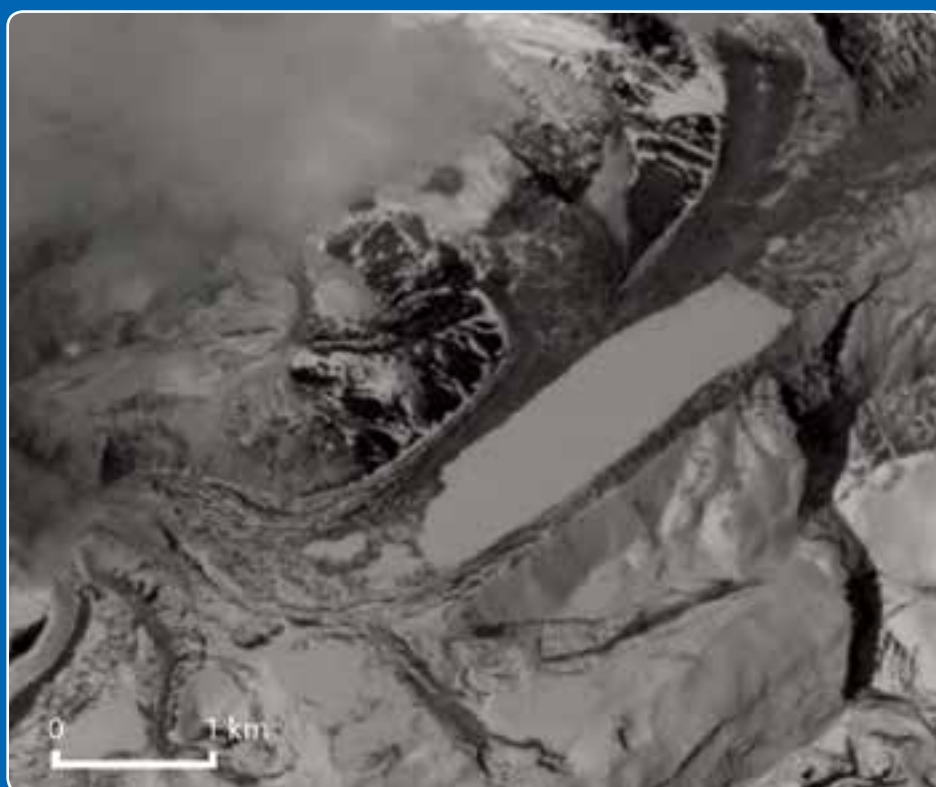
**Figure 31: Lakes in TAR, China just across the border from Tsho Rolpa. The red dots identify lakes that appear completely unchanged from their state just prior to the earthquake**

Satellite images of lakes in Tibet Autonomous Region (TAR) of China, just across the border from Tsho Rolpa, also show no evidence of outburst floods or major damage to their moraines (Figure 31). The Chinese Academy of Sciences (CAS) is tracking the effects of the earthquake in TAR. Although many landslides occurred there, the moraine dams of the glacier lakes checked by the CAS team appear to have been unaffected by the quake. The red dots in Figure 31 identify lakes that appear completely unchanged from their state just prior to the earthquake.
